Geodetic Works during the Estimation of the Vertical Displacement of a Bridge under a Load Test

Gučević, J., Delčev, S., Ogrizović, V., Pejić, M., Popović, J., and Pejović, M.

University of Belgrade, Faculty of Civil Engineering, Department of Geodesy and Geoinformatics, Bulevar kralja Aleksandra 73, 11000 Belgrade, Serbia, Website: www.grf.bg.ac.rs, E-mail: jgucevic@grf.bg.ac.rs, delcev@grf.bg.ac.rs, vukan@grf.bg.ac.rs

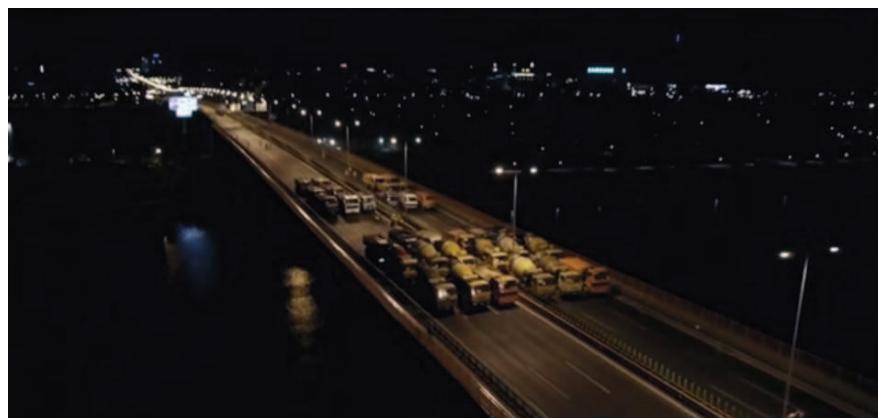
Figure 1 Gazela Bridge

Belgrade's busiest bridge over the Sava River is the Gazela Bridge. Its chief designer is Milan Đurić, Professor at the Faculty of Civil Engineering in Belgrade. The bridge was built in the period from 1966 to 1970, as a combination of beam and vault, and is 332 meters long and 27.5 meters wide.

Total roadway width is 21.8 meters - has three lanes in both directions. The bridge was designed to carry about 40,000 vehicles a day, and nowadays it carries around 165,000 vehicles per day. As a probable consequence of the lack of the bridge maintenance in the last 40 years, in 2010 a crack was registered in the main frame and its rehabilitation soon started.

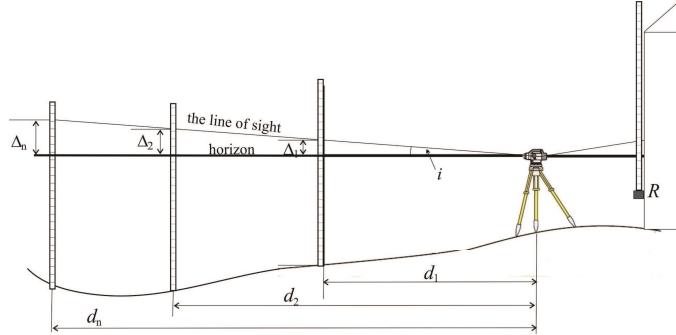
Figure 2 Detailed levelling

To determine the errors differences in heights of profile points, the application of detailed levelling was used. When using the detailed levelling it is necessary to take into account the non-parallel lines of sight and the level axis, i.e. angle i which the line of sight forms with the horizon. Angle i acts as a systematic error in the function of the distance between the instrument and the rod, Fig. 2.

$$\tan i = \frac{\Delta_j}{d_j}, \quad j=1 \dots n, \quad (1)$$

Considering that it is a detailed levelling which involves the application of various line of sight lengths, it is necessary to calculate the allowed values of the angle i . The calculation is done so that the accuracy of height difference measurement at the station is within the planned accuracy of determining vertical displacement $\sigma_{VD} = 1 \text{ mm}$. Starting from the required accuracy of vertical displacements ($\sigma_{VD} = 1 \text{ mm}$), expression (2) and expression (1), we get:

By rearranging the expression (3) and substituting appropriate numerical values we get $\sigma_{\Delta h_i} = 0,997 \text{ mm}$. For maximum projected length of the line of sight of 65 m, according to the expression (1) we get the value of the angle i of $3.2''$. In accordance with the obtained parameters the measurement was realised.

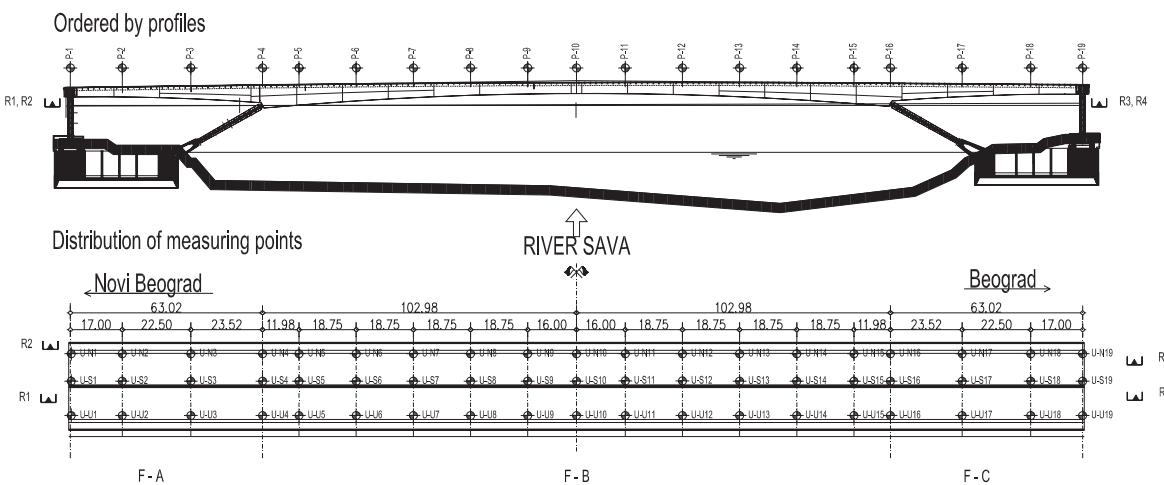
Figure 3 Distribution of profiles and measuring points

Height differences were measured in relation to 4 benchmarks R1, R2, R3 and R4, stabilised on columns K1 and K2 from the side of Novi Beograd and columns K3 and K4 from the side of Belgrade. The plan stipulated that two working groups carried out measurements on the Novi Beograd side in the profiles from U- 1 to U- 10, and the other two working groups on the side of Belgrade in the profiles from U- 19 to U-10. The measurements were carried out with different line of sight lengths. For each profile point, the length up to 1 cm was measured, and reading on the rod up to the tenth of a millimetre. Loads were carried out in phases F-A, F-B and F-C. F-A phase refers to 4 profiles and 5 load dispositions of the bridge span along the river bank towards Novi Beograd. Phase F-B refers to 11 profiles and 10 load dispositions of middle span of the bridge. Phase F-C refers to 4 profiles and 5 load dispositions of the bridge along the bank to Belgrade. A total of 20 load dispositions were carried out that lasted an average of 20 min. Figure 3 shows the distribution of profiles and measuring points (the two middle profiles that go mid asphalt are not shown).

Measurement data processing and determination of vertical deflections of 19 profiles with 5 measuring points include: calculating point heights on the profiles, forming differences and comparing the obtained values. The method of calculating deflections, within each phase, is conducted in the traverse of geometric levelling, related to the height of benchmarks H_{R_1} and H_{R_3} and the traverse related to the height of benchmarks H_{R_2} and H_{R_4} . In order to determine heights at measuring points by profiles we first determined heights of binding points H_a .

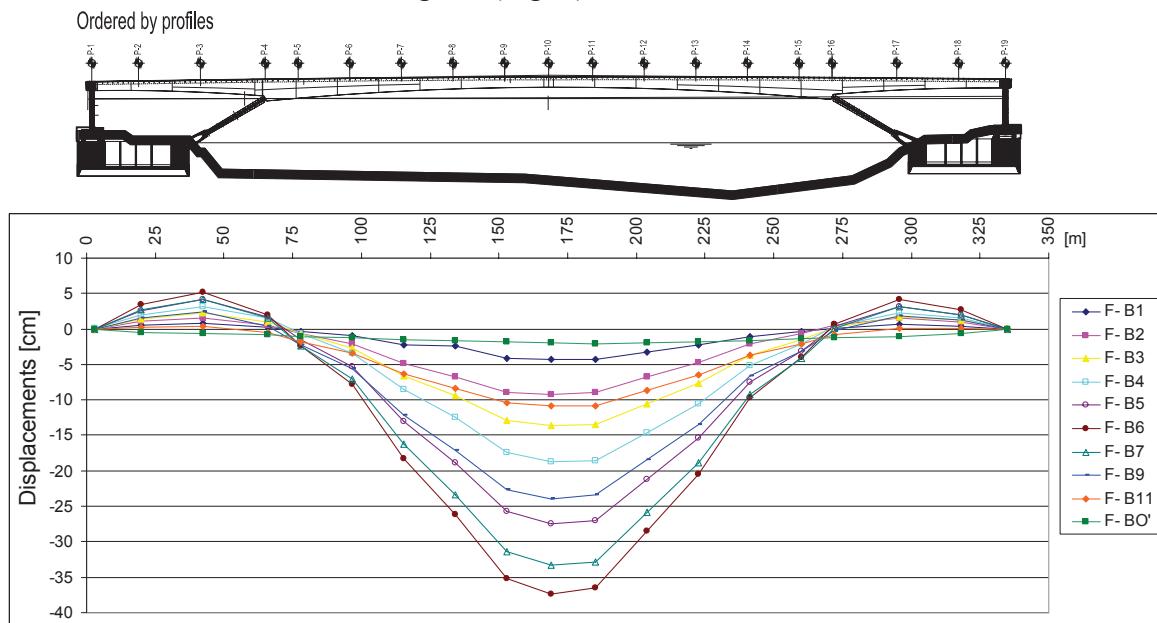
Figure 4 The diagram of the loading phase F-B

For the disposition of the loading phase F-B differences in relation to the initial disposition were formed and shown in the diagram (Fig. 4).

The final and independent quality control of the data obtained was carried out by analysing the results of measurements of the profile 10 considering the fact that it was a common profile for the working groups R1 and R3, as well as for groups R2 and R4. By analysing differences in all stages and load dispositions on the common profile 10 for all working groups, the mean value of differences of 0.27 mm was established, which is within normal limits for this type of work.

The size of deflection at the measuring points for realisation of the load disposition is in the interval of +5.2 cm to -38.3 cm. The values obtained are consistent with the expected values confirming the stability of the steel structure, and on August 11, 2012, the project of reconstruction of the Gazela Bridge was completed.
