Automated Inspection within Galleries of Large Dams

Helena LAASCH*, **Nathalie RYTER***, **Isabelle STEFFEN***, **Alexander RESKE**,
Ephraim FRIEDLI, **Valens FRANGEZ**, Switzerland

SUMMARY

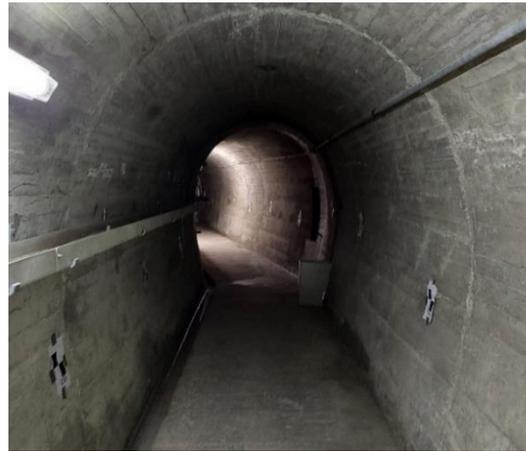
Figure 1: Conditions inside the gallery of the arch-gravity dam

The measurement site was an arch-gravity dam in the Swiss Alps. The gallery of the dam was around 220 m long and its diameter was about 1.80 m. Nine consoles installed in the gallery served as ground control points (GCPs) and are part of a permanently installed geodetic network to monitor the dam and build the dam coordinate system. The overall geometry of the network is not optimal for measurements since the shape of the tunnel is long and narrow, meaning the GCPs are almost on a line. The environment is challenging due to the sparse and non-homogeneous lighting condition, the variable humidity, and the homogeneous, repetitive pattern on the surface of the concrete (see Figure 1).

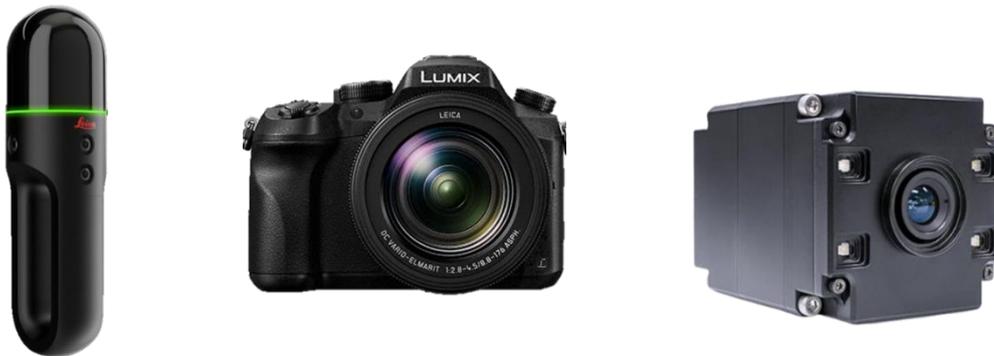
Figure 2: Sensors to be tested (from left to right): Leica BLK2GO [8], Lumix DMC-FZ2000 [9], Lucid Helios Time of Flight 3D camera [10]

In the context of this paper, three sensors (see Figure 2) were selected based on their functionalities and were tested in terms of their suitability for detecting cracks, i.e. an all-in-one solution, a sensor acquiring high resulted images, and an active sensor providing 3D point information.

The *Leica BLK2GO* is used as the all-in-one solution, high-resolution images were acquired with the *Lumix DMC-FZ2000*, and the depth images were captured with the *Lucid Helios Time of Flight 3D camera*. We refer to the mentioned sensors in the following parts as BLK2GO, DSLM, and depth camera, respectively. To facilitate the comparison of the three sensors, selected specifications have been collected in Table 1.

The *Leica BLK2GO* is a handheld imaging laser scanner. This mapping solution is based on the GrandSLAM technology which makes use of an IMU, visual and light detection and ranging (LiDAR) simultaneous localization and mapping (SLAM) and is used for the positioning of the *BLK2GO*. Besides a point cloud and a trajectory, the system also provides for each image a timestamp, position, and orientation with respect to the mapping frame. Since it is a one-button solution, it is not possible to change any acquisition settings of the cameras or the LiDAR. The digital single-lens mirrorless (DSLM) camera *DMC-FZ2000* from *Lumix* is a system camera that can acquire images and videos. The latter can then be used to extract the individual image frames. The depth camera *Helios Time-of-Flight* by *Lucid Vision Labs* is an active sensor that provides depth and intensity images. The depth camera is controlled by a Python script on an external computer, where the recorded data is stored. An external power source is also required for the operation. The most important parameters adjusted in our case were exposure time, operating distance, averaging over frames, and gain.

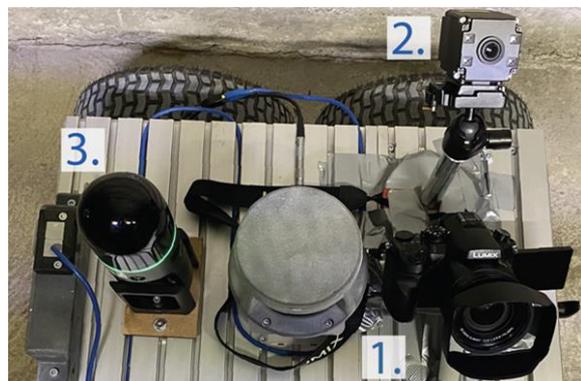
Figure 3: Sensors (1. DSLM, 2. depth camera, 3. BLK2GO) mounted on the Super Mega Bot

A four-wheeled robot, the *Super Mega Bot* from *Inspectorbots* and customized by the *RobotX Center for Robotics*, was used to carry the sensor. The robot was used to assess the applicability of such a vehicle in the dam environment. The sensors mentioned in Chapter 2.2.1 were mounted on the platform, as shown in Figure 3. Thus, their relative positions with respect to each other stayed the same during the experiments.

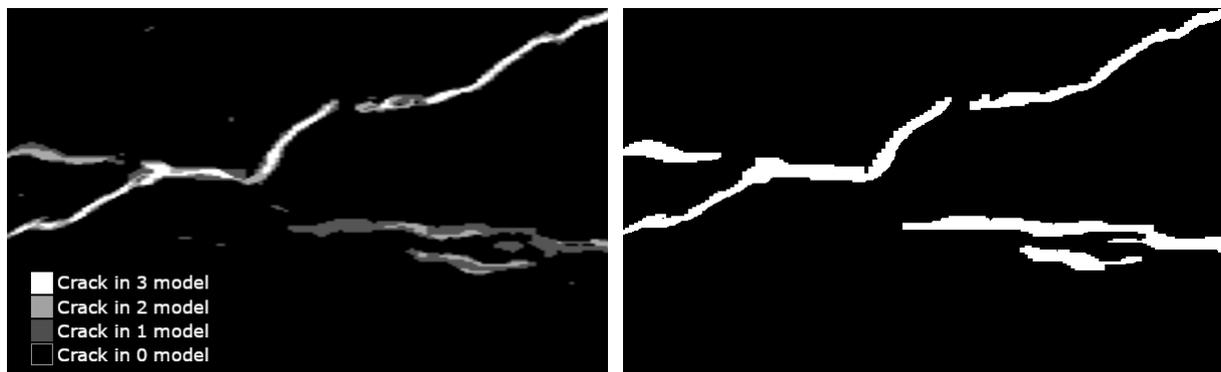
Figure 4: Cumulative image of the three selected crack detection models (left) and the resulting image from the combination of the three models (right)

was trained with intensity images obtained by profile laser scanning data of tunnels. For the CNN model training we used a combination of images containing cracks acquired in different environments (i.e. provided by *AXPO* [18]) as well as images acquired on-site in the dam gallery. Combinations of the optimizers adam and stochastic gradient descent (SGD) [19], and the loss functions lovasz, focal, dice, and binary cross-entropy (BCE) [20] were used for the model training. The model with the adam optimizer and the focal loss function resulted in only few false-positive values but detected only wider cracks. The model with the adam optimizer and the BCE loss function had many false-positive values but also detected thin cracks. The model with the adam optimizer and the dice loss function was a compromise between the previous two models. To predict the cracks, a combination of these three best-performing models was used. The cracks were predicted with each model and the resulting binary images were overlaid and merged. The result was a grayscale image with four shades of gray used for the number of models that predicted a crack at a pixel-level (see Figure 4 left). This combined image represents the probability of the existence of a crack. For the final predicted crack image, a majority voting was performed. Less probable pixels, which are only predicted with one model are labeled as a crack when they belong to an area which already contains some pixels that are detected by two or more models. The resulting image (see Figure 4, right) reduced the number of false-positive detected cracks compared to the image predicted with only one model.

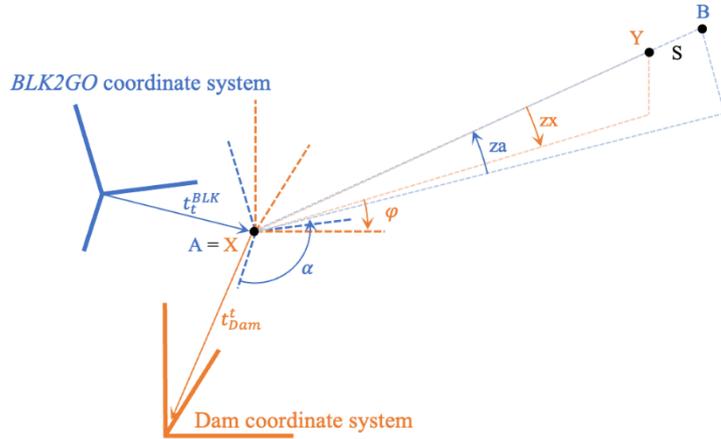
Figure 5: Transformation between *BLK2GO* and dam coordinate system

Figure 5 and Equations 1 and 2 show how the transformation between the *BLK2GO* and the dam coordinate system was done. First, the *BLK2GO*

coordinate system was translated and rotated into the first target point so that the x-axis pointed in the direction of the second point. After scaling in the x-direction to reduce the drift, the rotation and translation into the dam coordinate system were performed.

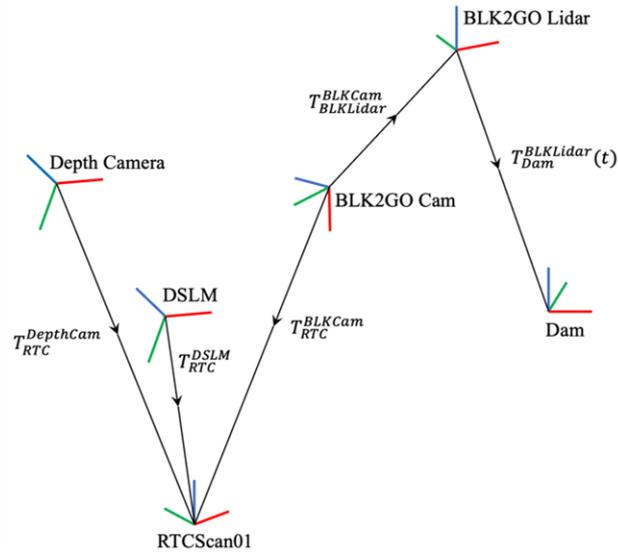
Figure 6: Different coordinate systems and their known transformation matrices used in the data

In the next step, we estimate the trajectory of the DSLM and the depth camera based on the known constant offset between the sensors and *BLK2GO*. For simplicity, the following is shown only for the DSLM, however it can be also applied to the depth camera setup. In order to calculate the offset between the DSLM and the *BLK2GO*, an image of the same scene was acquired from each sensor, with the robot being stationary. These images were referenced with the use of the *RTC360* point cloud. Distinctive points were manually measured in the images and the point cloud. Out of these corresponding points, the extrinsic camera parameters were calculated with the direct linear transformation (DLT) [21]. Figure 6 gives an overview of all coordinate systems and their known transformations.

The transformations from both sensor systems to the *RTC360* coordinate system $T_{RTC}^{DSL M}$, T_{RTC}^{BLKCam} are known through the DLT. The transformation $T_{BLKLidar}^{BLKCam}$ from the *BLK2GO* camera to the *BLK2GO* trajectory is given from the calibration of the instrument. $T_{Dam}^{BLKLidar}(t)$, which describes the transformation from the *BLK2GO* trajectory coordinate system to the dam coordinate system, was given by georeferencing the trajectory for each timestamp. Finally, Equation 3 shows the entire transformation from the DSLM coordinate system to the dam coordinate system.

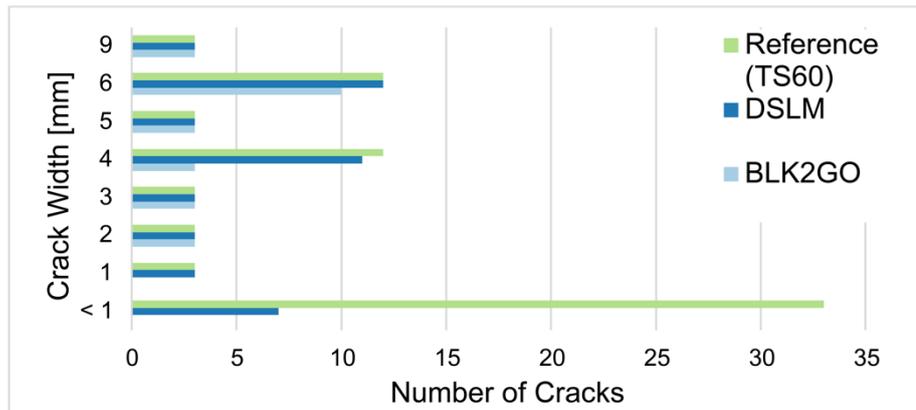
Figure 8: Number of detected cracks (in one image per section per run) of both sensors compared with the number of reference cracks in dependency of their widths

We were able to successfully detect cracks in the images of all sensors (see Table 3 and Figure 9). Figure 7 shows the number and width of detected cracks for each sensor type. In the DSLM

images, 97 % of the cracks wider than 1 mm could be detected by the self-trained CNN. Most of the cracks wider than 2 mm were detected in the *BLK2GO* images. To avoid running out of memory, we tiled the images, i.e. we cut the images used in the prediction step into tiles of size 896 x 896 pixels (see Table 2 and Figure 8). The disadvantage of this tiling is that cracks are more interrupted, wide cracks are not always detected, and the number of false-positive values is higher. In the generated orthophotos from the photogrammetric model, cracks are detected but not to their full extent.

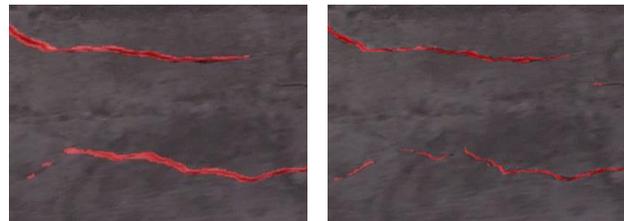
Figure 7: Result of the crack detection algorithm (red: crack) with a subsampled image (left) and with a tiled image (right)

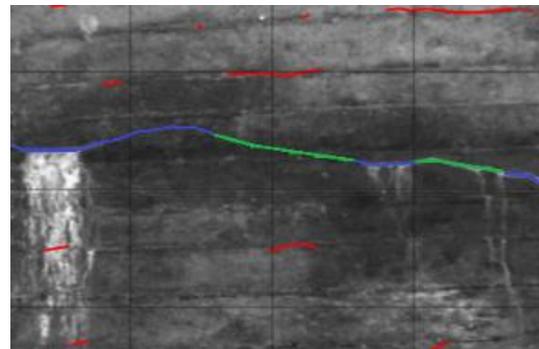
Figure 9: Cracks on the intensity image of the depth camera (green: correct detected, blue: false-negative values, red: false-positive values)

Table 2 shows the percentage (%) of the crack lengths that were detected within the detection algorithm. Besides from the percentage values, very important indicators for the performance of the CNN are the numbers of false-negative predictions (--) and false-positive predictions (-+). The false-negative predictions should be avoided, and false-positive predictions should be minimized, meaning, it is better to detect a crack that is not actually a crack, rather than not detecting a crack at all. Comparing the cracks detected using the orthophoto with respect to the other two DSLM results (i.e. using subsampled and tiled datasets), the percentage of detected cracks is lower. Additionally, the false-negative values are lower by 10%. For the intensity images acquired with the depth camera, the crack detection algorithm was able to predict cracks that are wider than 6 mm, however about 60% of the crack was not detected (see Figure 9).

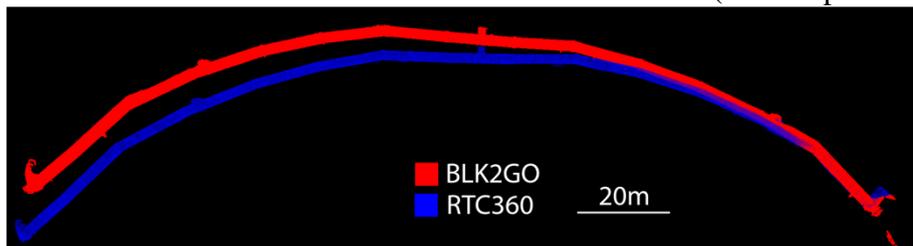
Figure 10: Indication of a drift of the *BLK2GO* point cloud compared to the *RTC360* point cloud, which served as ground truth (top view)

The accuracy of the trajectory and the point cloud directly influence the accuracy of the 3D coordinates of detected cracks. As described in Chapter 3.3, the *BLK2GO* trajectory indicates a large drift due to the challenging gallery shape, i.e. elongated tunnel. The impact of the drift on the point cloud estimation is shown in comparison to the *RTC360* point cloud (see Figure 10). The two point clouds were aligned based on the calculation of the transformation between the GPCs in the *RTC360* dataset and the *BLK2GO* dataset (see Chapter 3.3).

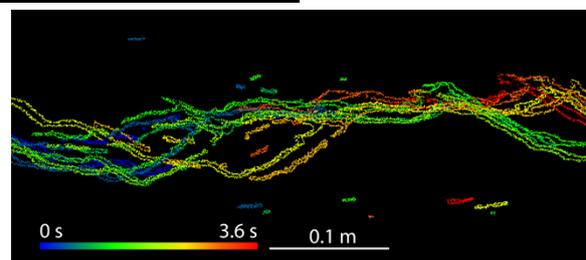
Figure 11: Projected cracks from nine consecutive images ($\Delta t=0.4$ s)

The impact of the drift of the trajectory onto the detected cracks is shown in Figure 11. The figure shows extracted cracks of nine consecutive DSLM images, which appear shifted with respect to each other, on a level of a few centimeters. Furthermore, the distances between the georeferenced *BLK2GO* targets and the targets of the *RTC360* point are shown in Table 4. The deviations increase from the

start of the gallery, i.e. part used for alignment, to the end, where they reach several centimeters. To avoid influences of our special setup on the trajectory, the *BLK2GO* was carried by hand in run four. The deviations of run four are in a similar range as the others which leads to the assumption that the setup has no impact on the quality of the trajectory. The cloud-to-cloud (C2C) distances between the *RTC360* and *BLK2GO* point clouds are also shown in Table 4. The C2C differences are smaller since the profile of the gallery does not change much. As the drift is along the axis of the gallery, not the whole impact of the drift on the point cloud can be shown with the C2C distances.

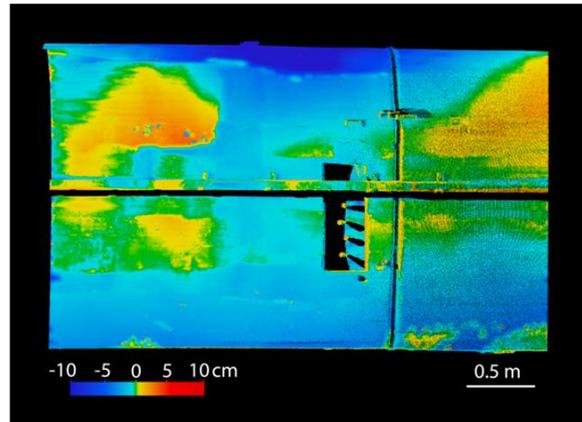
Figure 12: C2M comparison between photogrammetric model and RTC360 point

In the case where the georeferencing is done with a photogrammetric model (see Figure 12) the accuracy of the cloud-to-mesh (C2M) distance is higher with a mean of 2.8 cm and a standard deviation of 2.4 cm, as compared to the C2C distance of the *BLK2GO* point cloud (see Table 4). The achieved accuracy is in the centimeter range, therefore it is considered sufficiently good for this application. One of the disadvantages of using the photogrammetric model is that the computation takes much more time than using the trajectory. Also, if the *BLK2GO* point cloud is partitioned into smaller sections, which are then individually transformed, the drift of the trajectory could be significantly reduced.
